**Jim D. Koontz & Associates, Inc.**  
**P. O. Box 1054**  
**Hobbs, New Mexico 88241**  
**Ph 575 392 7676**  
**Fx 575 392 7602**

Re: Hail Resistance Testing  
Wind Testing  
JDK 60-48-1

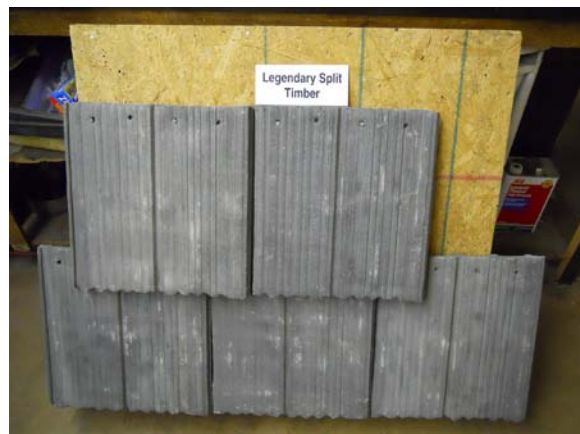
Laboratory Photograph 3

The target samples were initially constructed and impacted with ice spheres per National Bureau of Standards Procedure 23, **Exhibit No. 4**. This procedure involves building target samples as depicted in laboratory photographs 1-7. The

samples were mounted in a vertical position and sprayed with water at 40°F. The samples were impacted with ice spheres that ranged from 1.75 to 3.00 inches in diameter. A typical hail mold used in testing is depicted in laboratory photograph 8.

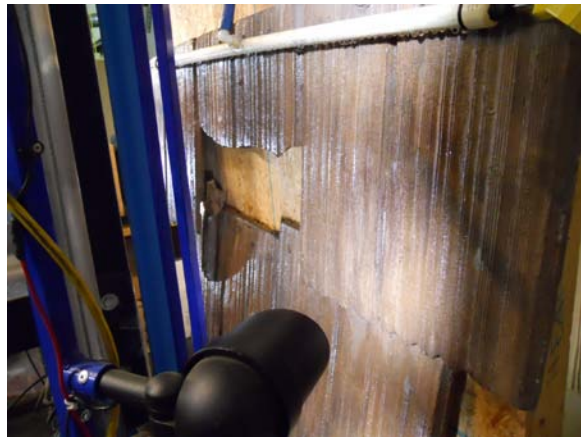
Laboratory Photograph 14

A pneumatic launcher utilized for the testing is depicted in laboratory photograph 9. Tile initially impacted with ice spheres 2.00 inches in diameter did not fail, with the exception of the New England Slate - Ultra-Lite Weight, as depicted in laboratory photographs 10-13. The tile were tested to failure (i.e. tile breakage) as shown in laboratory photographs 14-16.

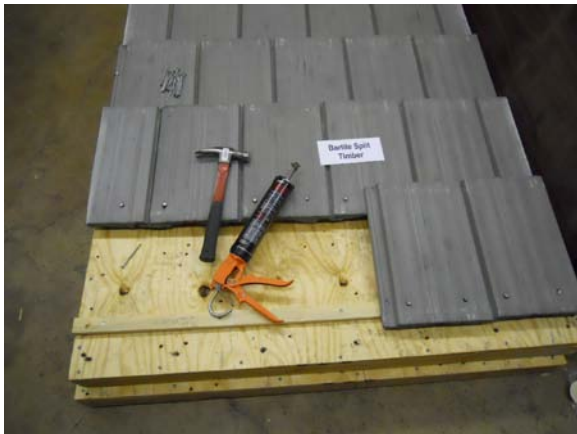
Laboratory Photograph 21

Targets were then constructed for wind testing as shown in laboratory photographs 17-22. Both hurricane clips and RT-600 adhesive were used in the construction of the targets as depicted in laboratory photographs 23-24. The hurricane clips were utilized at perimeter edge locations.

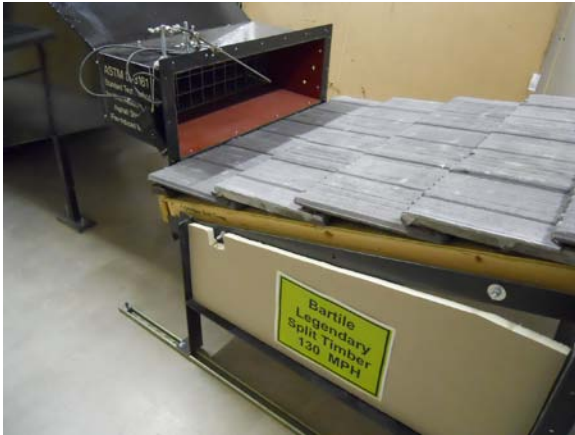
Laboratory Photograph 31

The tile targets were tested in accordance with ASTM D3161 procedures, **Exhibit No. 5**. This procedure involves placing the target at a slight angle in front of a fan and testing at various wind speeds. The testing is depicted in laboratory photographs 25-38.
